DOE/AL/62350-247
REV. 2

LONG-TERM SURVEILLANCE PLAN FOR THE MAYBELL, COLORADO DISPOSAL SITE

Uranium Mill Tailings Remedial Action Project

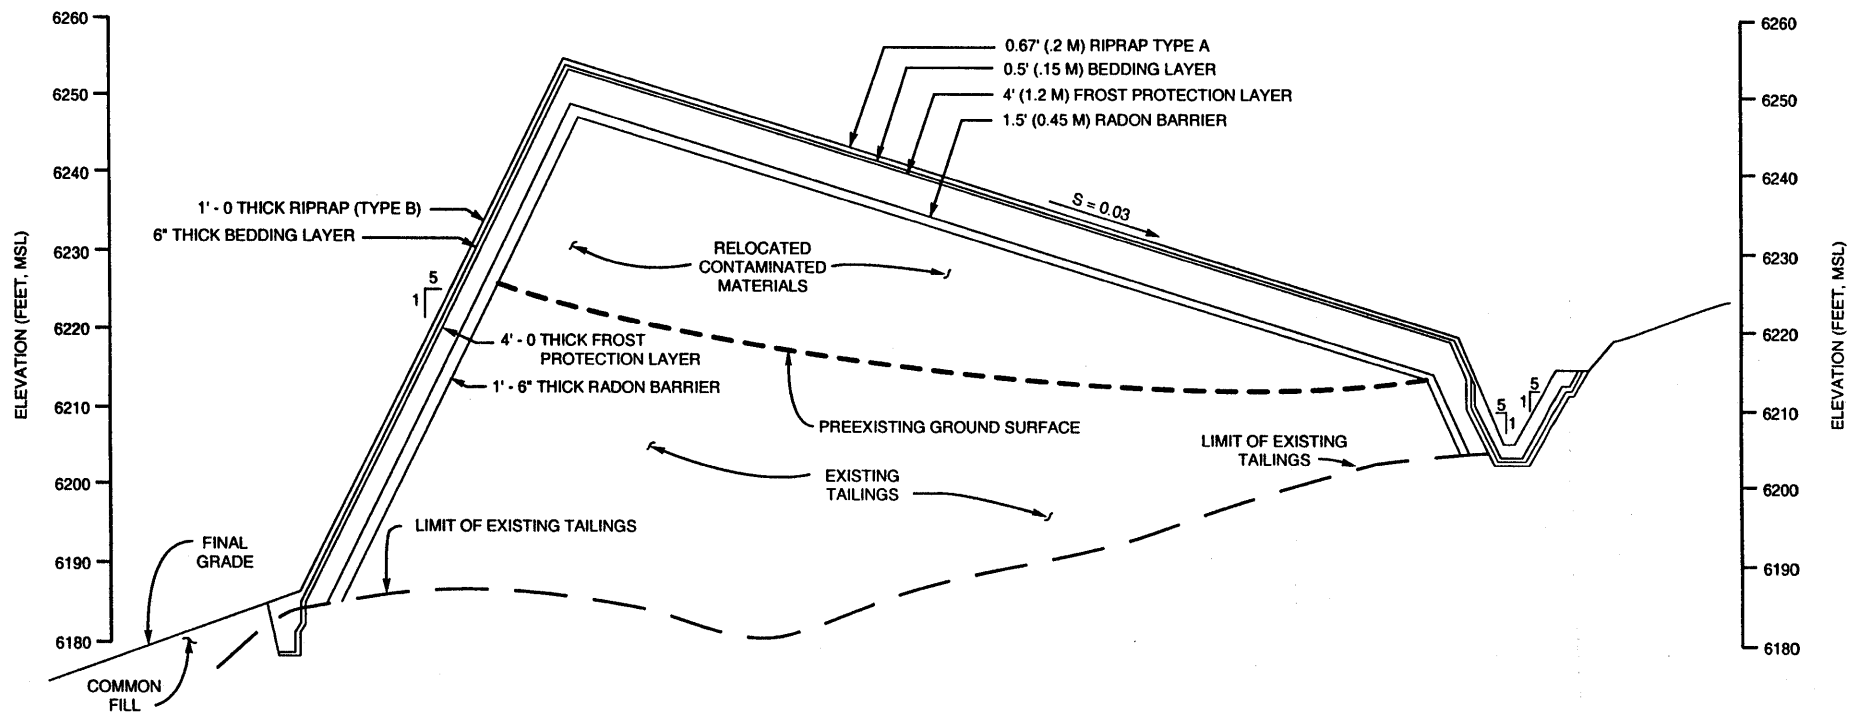
FIGURE 2.3
TYPICAL CROSS SECTION
MAYBELL, COLORADO, DISPOSAL CELL

Figure 2.3 shows a typical cross section of the disposal cell and cover. The cover consists of the following layers, starting at the bottom of the cover:

- A 1.5-ft (0.45-m)-thick radon/infiltration barrier, comprised of bentonite-amended clayey soil placed on top of the contaminated materials.

- A 4-ft (1.2-m)-thick layer of compacted soil to prevent the radon/infiltration barrier from the adverse effects of freeze-thaw cycles.
- A 0.5-ft (0.15-m)-thick layer of coarse-grained bedding material to act as a capillary break and filter, and to promote drainage of infiltrating water away from the radon/infiltration barrier.
- An 8- to 12- inch (20- to 30-cm)-thick layer of riprap (rock) to prevent wind and water erosion of the underlying materials.

The topslope of the cell slopes to the west at a grade of 3 percent. Runoff from the topslope enters a rock-lined ditch adjacent to the cell. The sideslopes of the disposal cell are at a 20 percent grade and are protected by riprap aprons on the south and east sides. On the north and west sides of the cell, the sideslopes are part of the main ditch that will carry surface runoff from the cell and adjacent off-cell areas. All upland flow will be intercepted and routed around the disposal cell by these ditches. Detailed engineering drawings of the disposal cell are in the site completion report (MK-F, 1999).

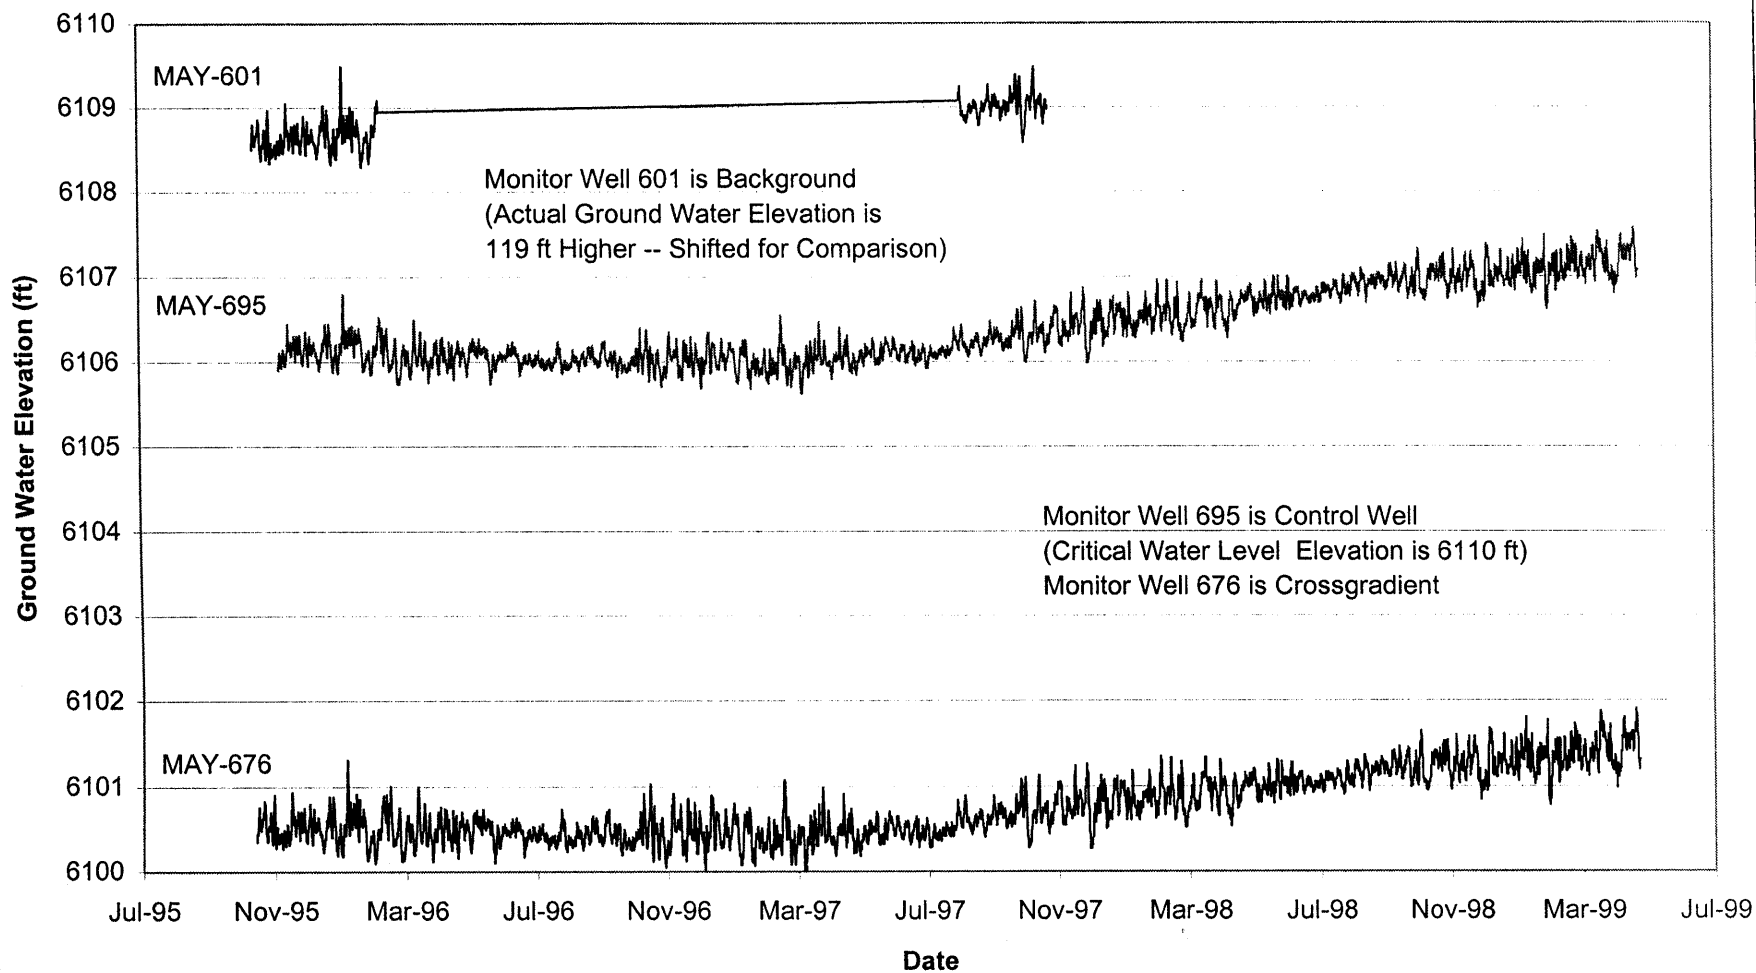
Figure 2.4
Datalogger Ground Water Elevations,
Maybell, Colorado Site

Evaluation of results of datalogger information from monitor wells 695, 601, and 676 during the period from November 1995 through May 1999 shows a slight increasing trend of ground water levels in mid-1997 (Figure 2.4). Available data from up-gradient background monitor well 601 also reflects this increase and this indicates the response in monitor well 695 is likely from regional causes rather than being directly related to disposal cell phenomena. On-going monitoring data from monitor well 601 should verify the regional ground water level patterns. Results of ground water level monitoring will be in DOE annual report to NRC.

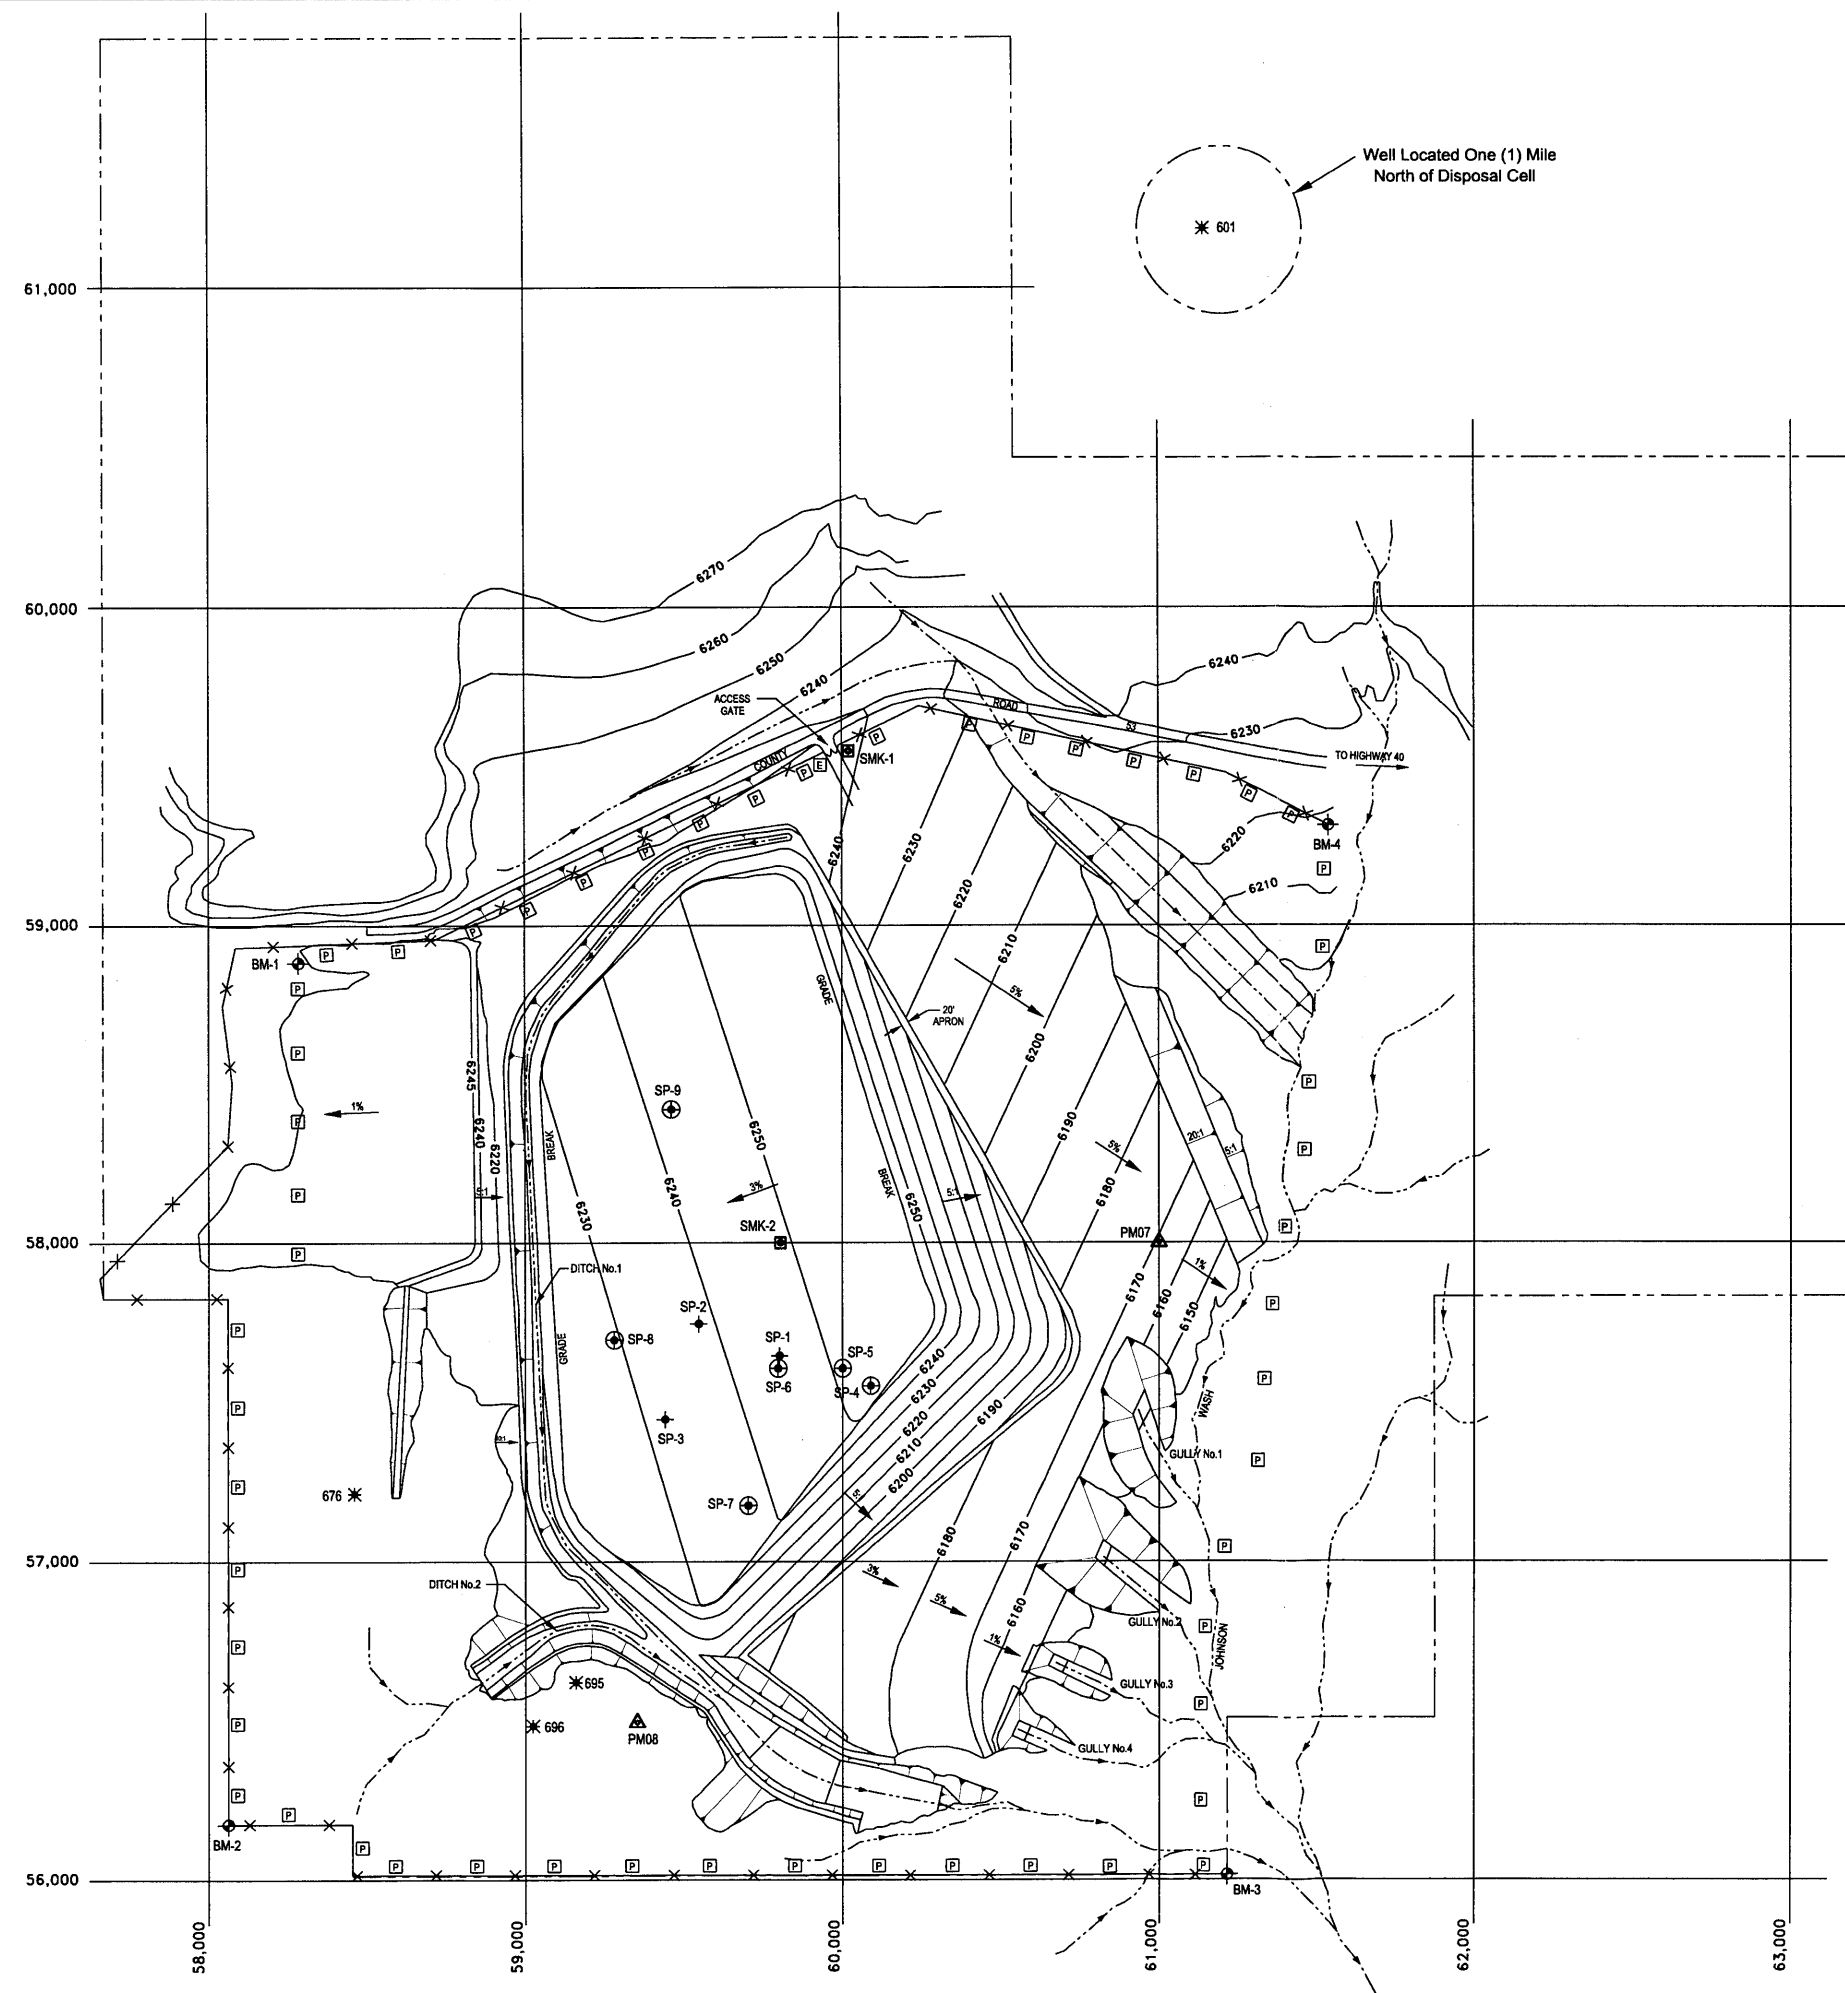
- TYPE I - SETTLEMENT PLATES (DISPLACEMENT MONUMENT) INSTALLED ON EXISTING TAILINGS PRIOR TO PLACEMENT OF CONTAMINATED MATERIAL FILL.
- TYPE II - SETTLEMENT PLATES (DISPLACEMENT MONUMENT) INSTALLED AT BOTTOM OF RADON BARRIER.

To monitor potential erosion damage, the inspectors will check for erosion and any changes in headcutting or sedimentation in and around gullies 1 through 4, between these gullies, and the toe of the disposal cell (Plate 1). Careful attention will be taken when traversing these gullies so as not to damage the placed erosion protection.

During construction, nine settlement plates, numbered 1 through 9, (see Plate 1) were installed for long-term monitoring (MK-F, 1999). Calculations indicate that significant settlements of the Maybell pile should occur during the first 5 years after placement of the frost protection layer. DOE will re-survey the elevations of the settlements of plates 1 through 9 for a period of five years (through 2003) following placement of the radon barrier. DOE will terminate the surveys after the fifth year unless settlement remains significant. Results of the surveys will be included in the annual reports to the NRC. (Reference the Final Completion Report, Volume 4, Appendix B, Design Calculation 14-392-01-01, Embankment Design-Settlement Analysis, MK-F, 1999).

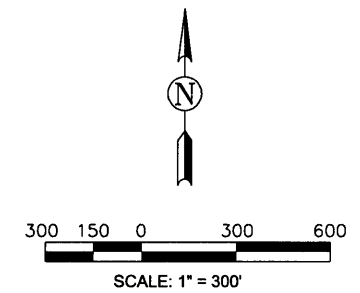
MONUMENT NO.	NORTHING	EASTING
SP-1 (SM-1)	N 57645	E 59800
SP-2 (SM-2)	N 57745	E 59545
SP-3 (SM-3)	N 57445	E 59440
SP-4	N 57550	E 60090
SP-5	N 57605	E 60000
SP-6	N 57605	E 59795
SP-7	N 57175	E 59700
SP-8	N 57700	E 59280
SP-9	N 58420	E 59460
